Manhole Inspection Summary

Manhole # S45KK_015MH

Insp Date: **4/2/08 9:41 AM**

Location Address: **Castle St**

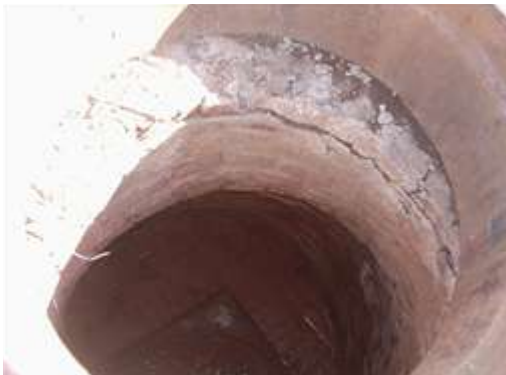
Defect 2

Chimney / Frame Adjustment ☒ Exists Material: **Brick** ☐ Parged Height: **12** (in.)

Condition: ☐ Sound ☐ Cracked ☐ Root Intrusion ☒ **Loose Brick** ☐ Deteriorated

Infiltration: ☐ None ☐ Joint ☐ Cracks ☒ **Mortar** ☐ Roots ☒ **Wall**

Adjustment Joint

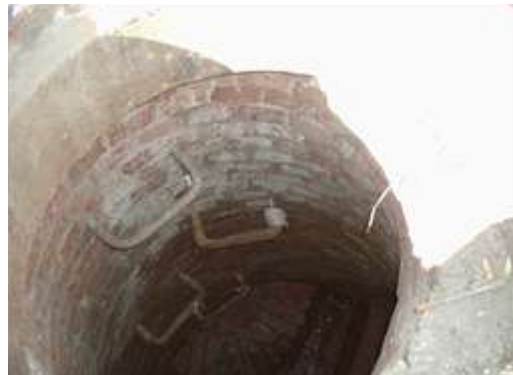
Defect 1

Frame Offset: **6** (in.) Condition: ☐ Sound ☐ Cracked ☒ **Leaks**

Frame Leaks

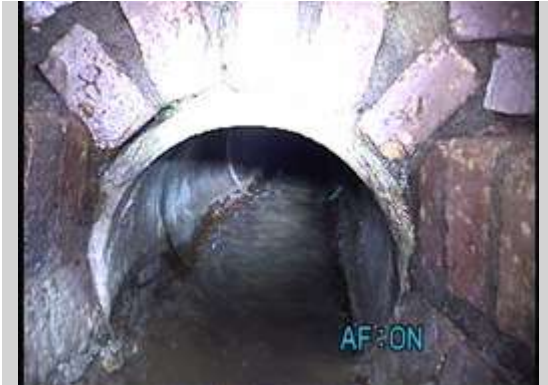
12 O'Clock Outflow

8 in. Circular Gravity Sewer
Pipe Out @ 12 O'Clock

Pipe Height: **8.4** (in.) Rod and Bar (Angled)
Pipe Material: **Clay** ☐ Pipe Lined
Invert Depth: **8.90** (ft.) Flow Characteristics: **Fast**
Deposits: ☒ None ☐ Mud ☐ Sludge ☐ Debris ☐ Grease
Silt Depth: (in.) Deposits Extent:
Infiltration: **None** Pipe Seal Cond: **Sound**

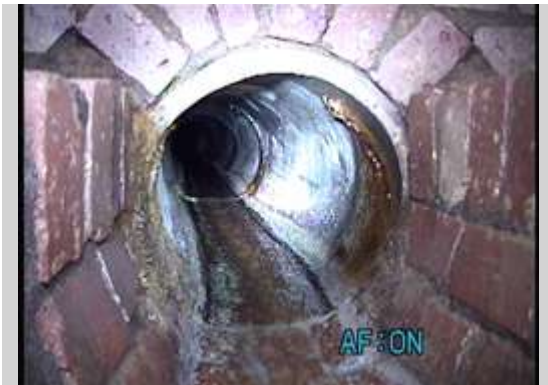
3 O'Clock Inflow

8 in. Circular Gravity Sewer
Pipe In @ 3 O'Clock

Pipe Height: **8.4** (in.) Rod and Bar (Angled)
Pipe Material: **Clay** ☐ Pipe Lined
Invert Depth: **8.80** (ft.) Flow Characteristics: **Fast**
Deposits: ☐ None ☐ Mud ☐ Sludge ☐ Debris ☒ Grease
Silt Depth: **2** (in.) Deposits Extent: **Light**
Infiltration: **None** Pipe Seal Cond: **Sound**
